Appendix I4

Biological Opinion & Biological Assessment

**Golden-cheeked Warbler Survey
US 281
from Loop 1604 to Borgfeld Drive
Bexar County, Texas**

**Submitted to:
Jacobs
Alamo Regional Mobility Authority
Texas Department of Transportation**

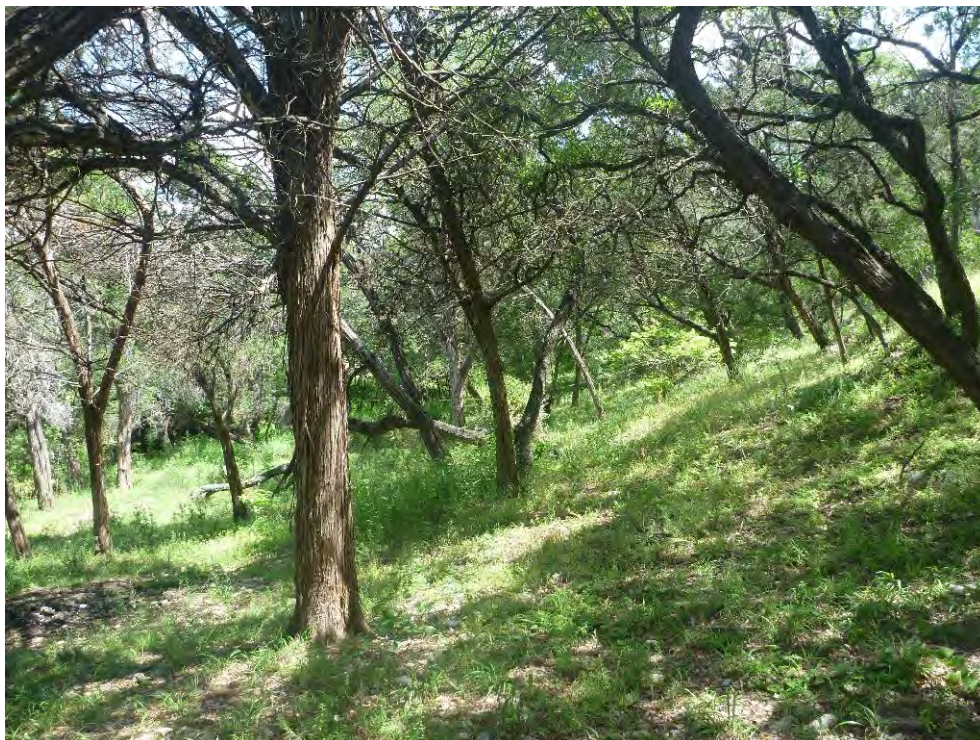
Block 1 -- Representative Habitat -- Note Manicured Understory

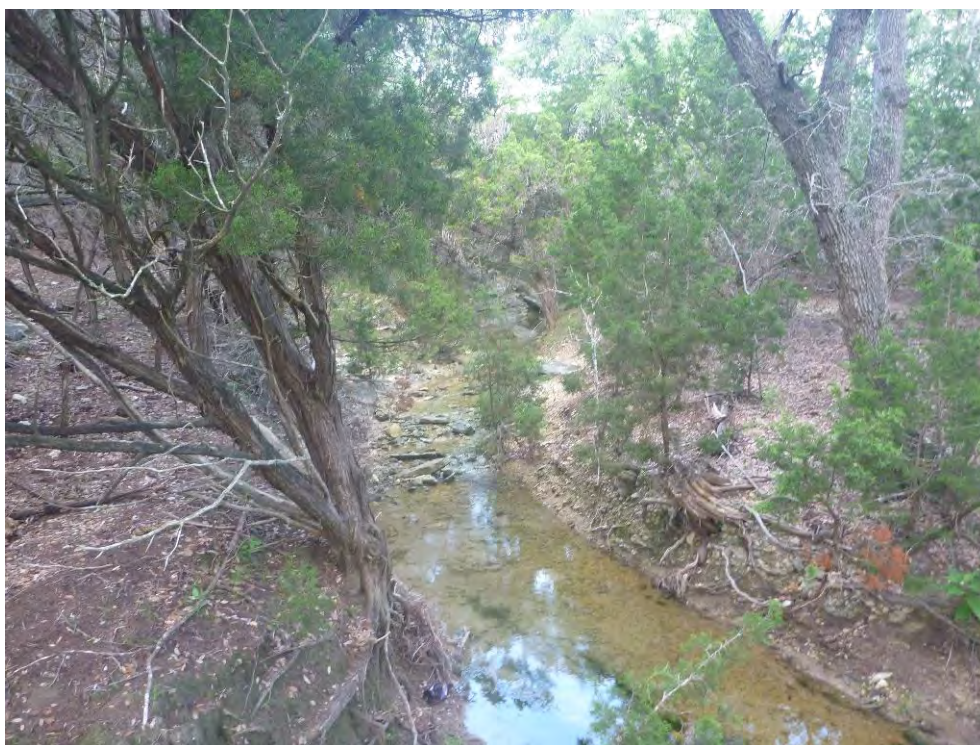
Block 2 -- Representative Habitat -- Note Overgrazed Condition

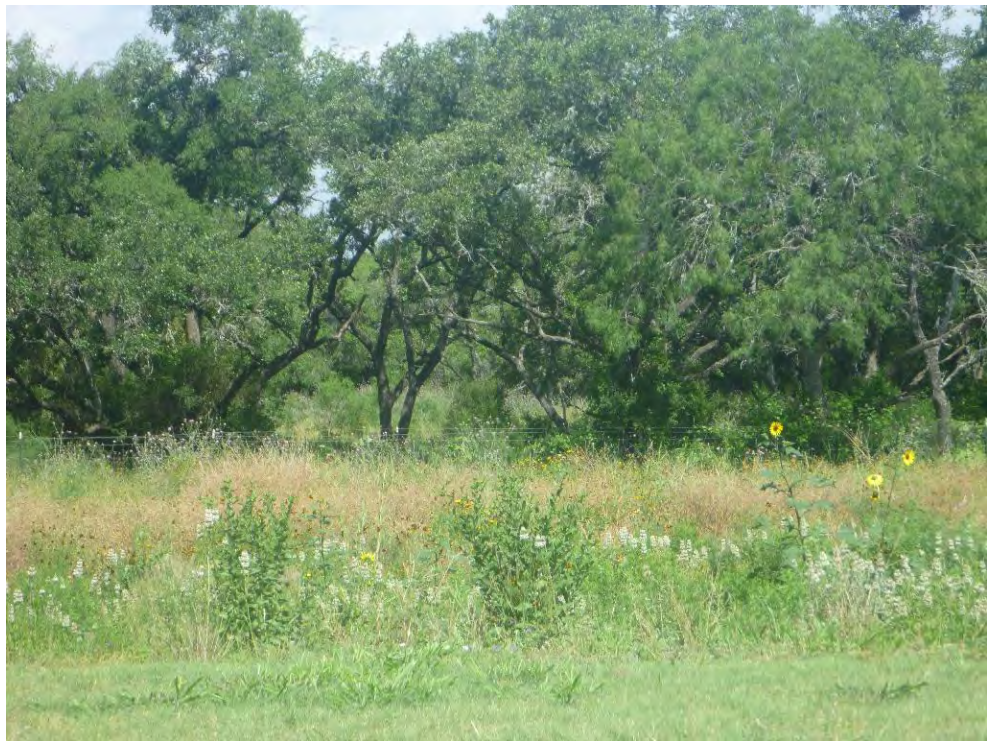
Block 12 – Dismissed from Survey due to Ashe Juniper Removal in Entire Block

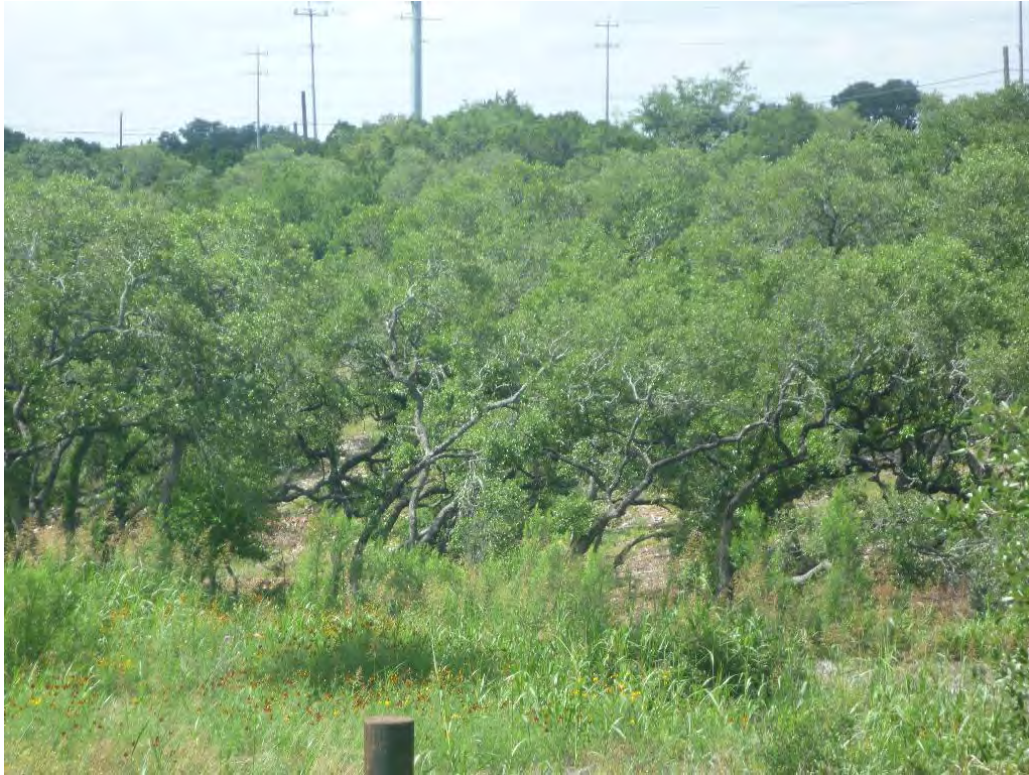
Block 7 – Portion Dismissed from Survey Due to Ashe Juniper removal

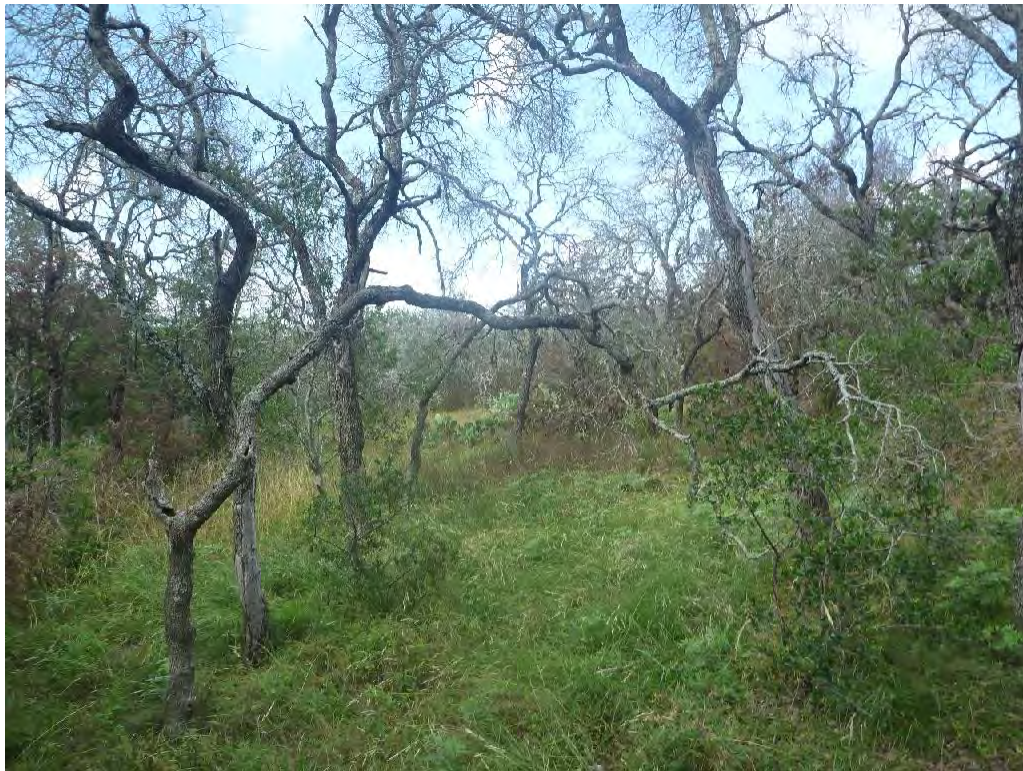
Block 9 -- Ailing Live Oaks Infected by Hypoxylon Canker

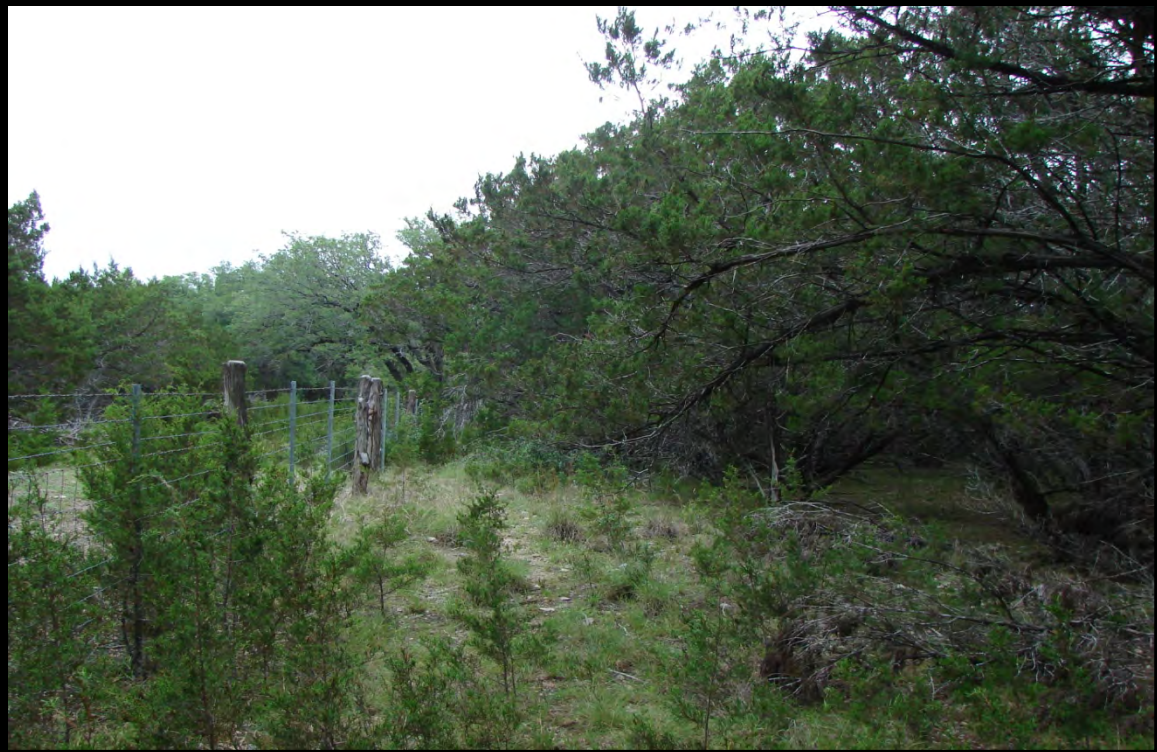
Photo 1. View of potential habitat added to Block 2, south of Cibolo Creek, looking north

Thirteen blocks of potential habitat totaling approximately 231 acres were identified and delineated within the 500-foot buffer from the proposed right of way during the 2009 habitat assessment (**Figure 2** in **Attachment 1**). These habitat blocks were further refined during the 2009 and 2010 survey efforts. Our general approach was to survey habitat mapped and refined during the 2009 habitat assessment and 2009 and 2010 surveys within the 500-foot buffer from the proposed right of way. Presence/absence surveys were conducted each season on the delineated habitat according to appropriate U.S. Fish and Wildlife Service (USFWS) protocols. A field visit was conducted on March 14, 2014, to reassess the potential habitat areas delineated in 2009. Approximately 32.14 acres of potential GCWA habitat was added to Block 2 on the northern end of the proposed project.

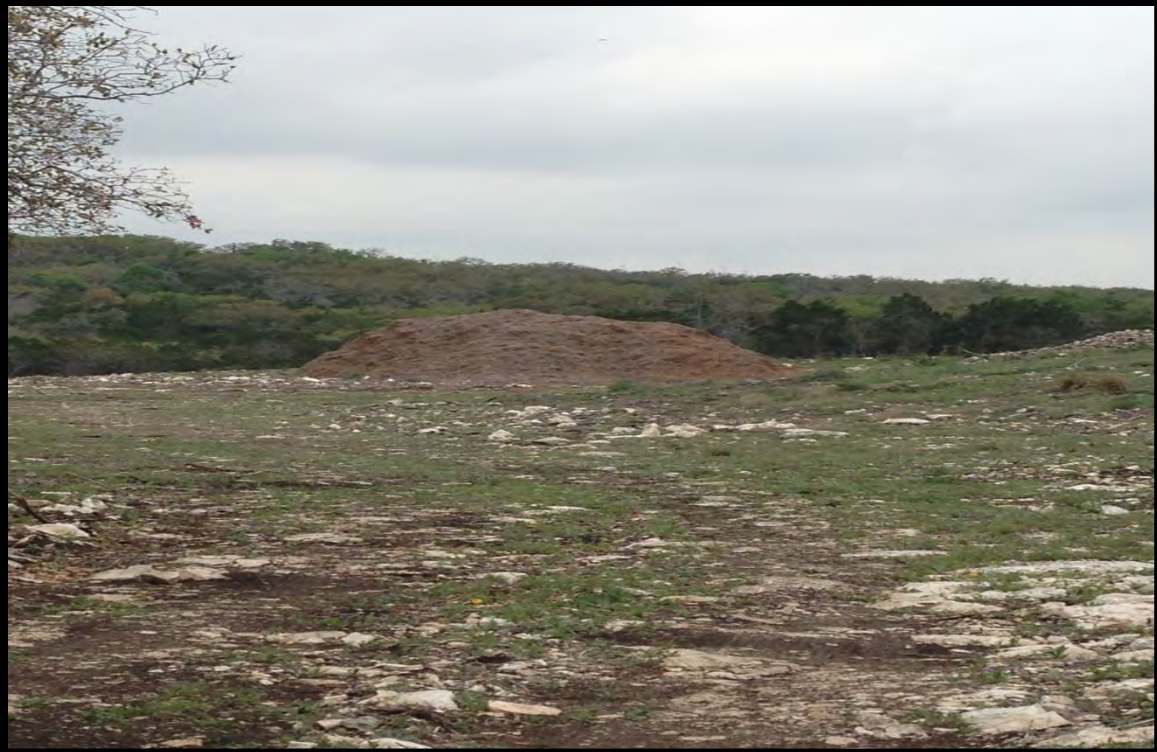
Photo 6. View of Ashe juniper clearing in Block 9, looking west

the project limits. Additionally, Ashe juniper clearing was noted in Block 9. During the 2014 breeding season, a rigorous direct survey was conducted on approximately 125 acres in blocks 1–3, 5–9, and 13 and surveyors checked all additional habitat available from public rights of way during the effort. After three years worth of effort, no GCWA have been detected and habitat quantity and quality losses continue due to current and pending development and both man-induced and natural woodland losses in the corridor. Ashe juniper clearing has taken place in blocks 6, 9, 11, and 12 and significant oak mortality has been observed on the west side of US 281 due to hypoxylon canker; a naturally occurring fungal condition particularly expressed in oaks during periods of environmental stress. In addition, nesting deterrents for the GCWA are prevalent and likely increasing due to urbanization, noise, and the prevalence of typical nest predator and social parasite species such as the Western Scrub Jay, Great-tailed Grackle and Brown-headed Cowbird. Given the negative survey findings to date and increasing downward spiral of habitat quality, it does not seem likely that the GCWA will utilize the project corridor.

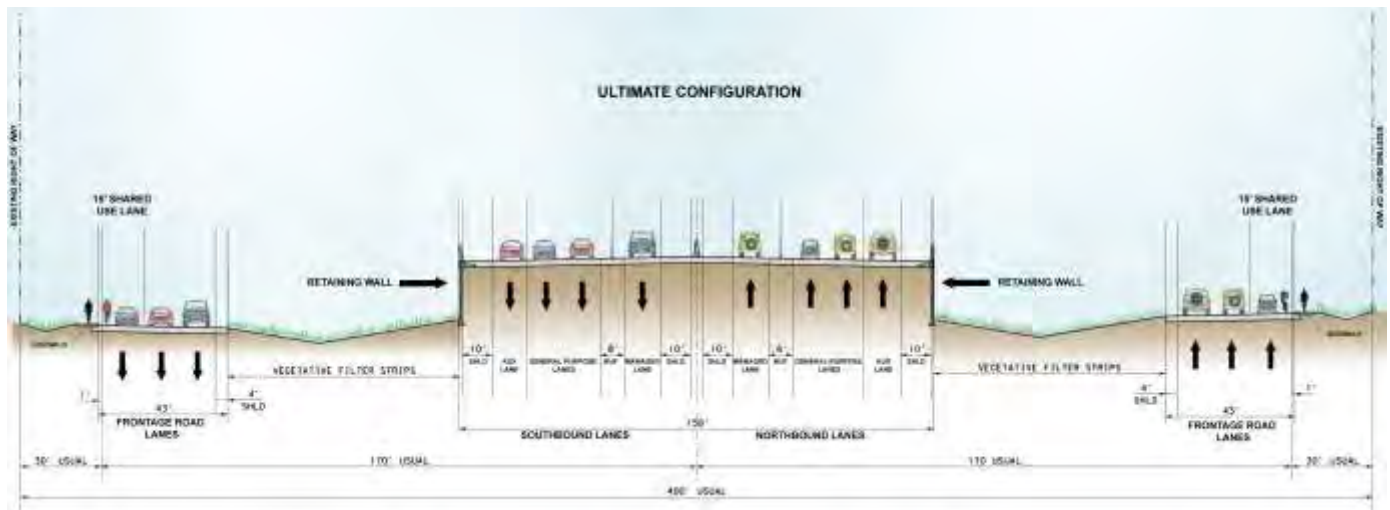
Figure E-1: Preferred Expressway Alternative typical section south of Stone Oak Parkway

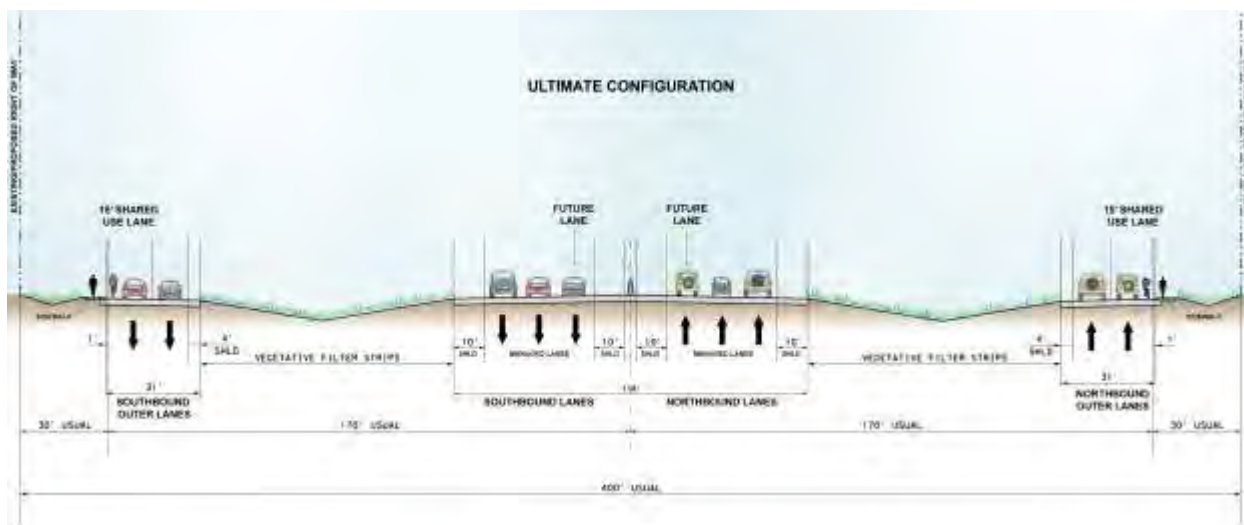
Figure E-2: Preferred Expressway Alternative typical section north of Stone Oak Parkway

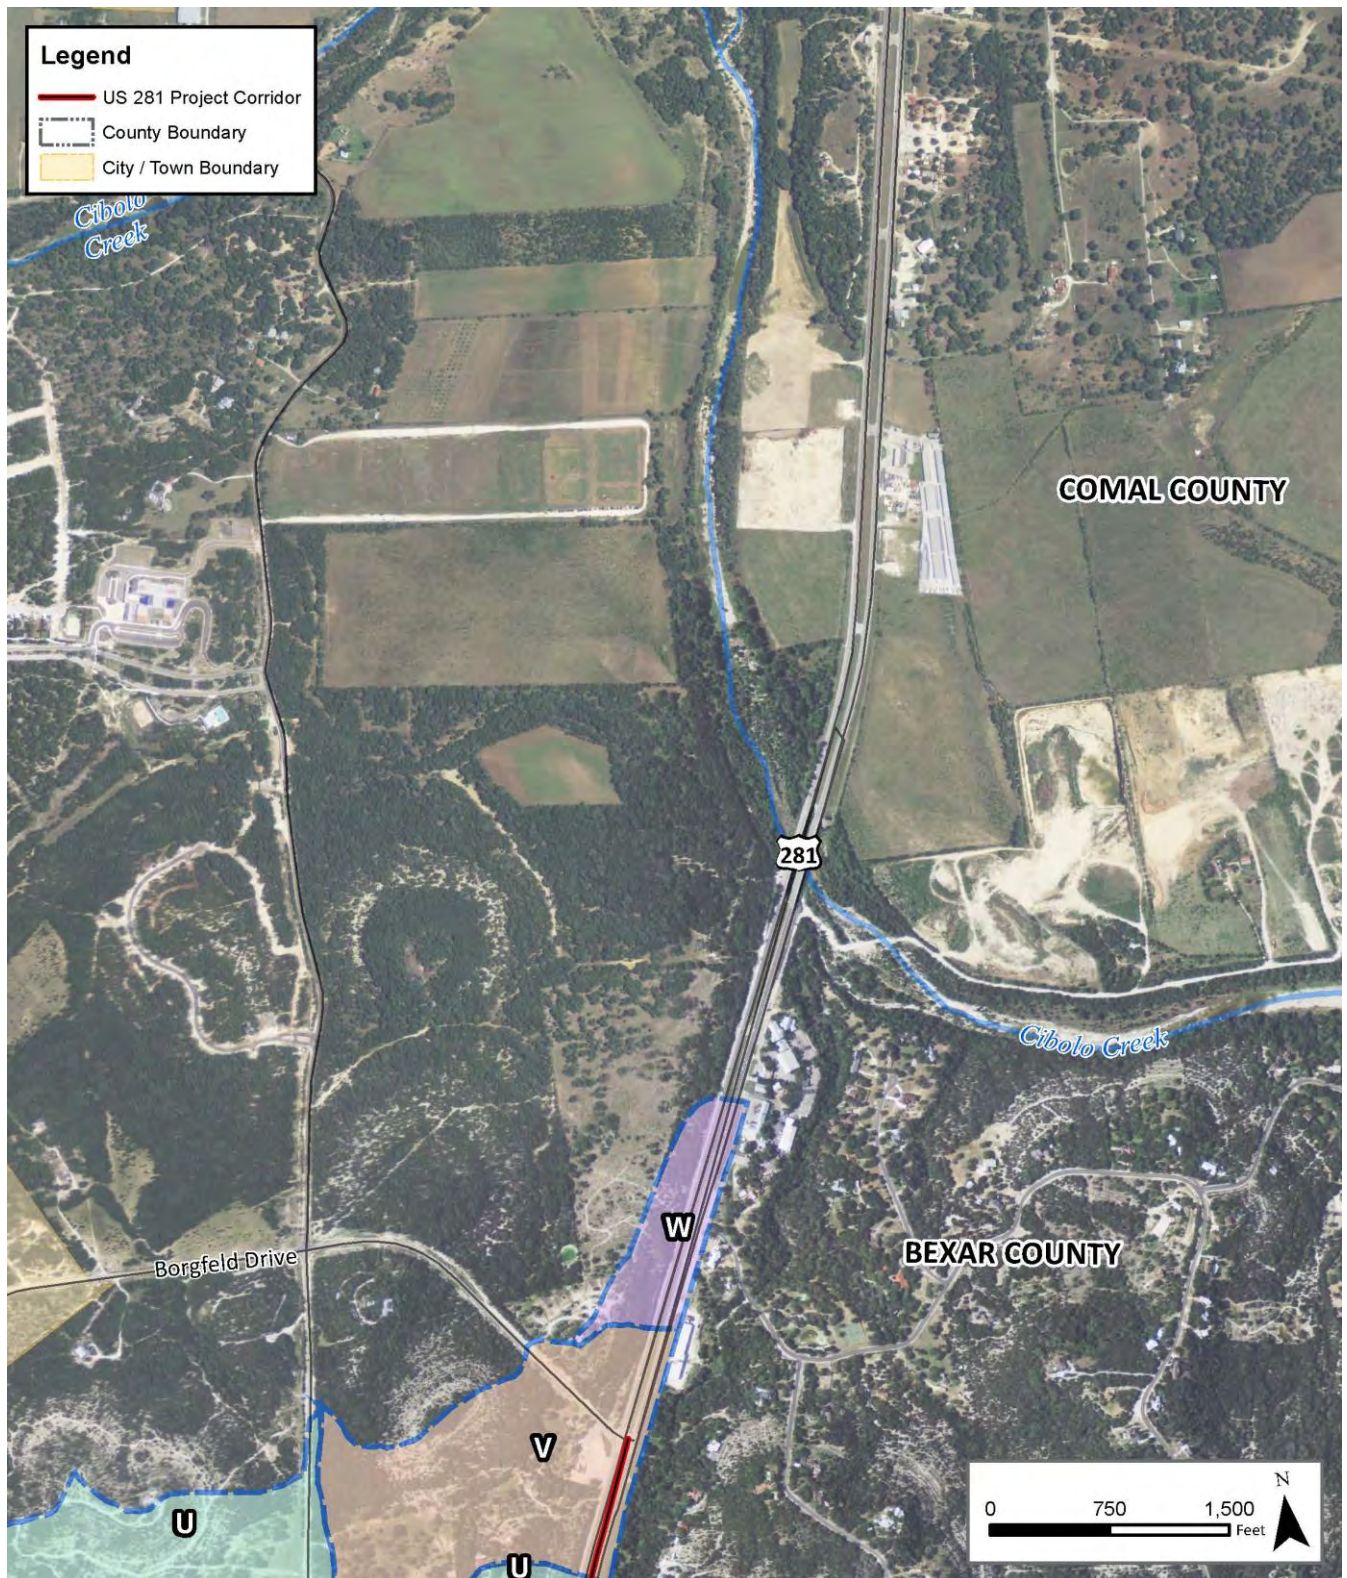
Figure E-3e: Drainage basins surrounding the Preferred Expressway Alternative
